S/24223
2 July 1992

REPORT ON THE TWELFTH IAEA ON-SITE INSPECTION IN IRAQ
UNDER SECURITY COUNCIL RESOLUTION 687 (1991)

26 May - 4 June 1992

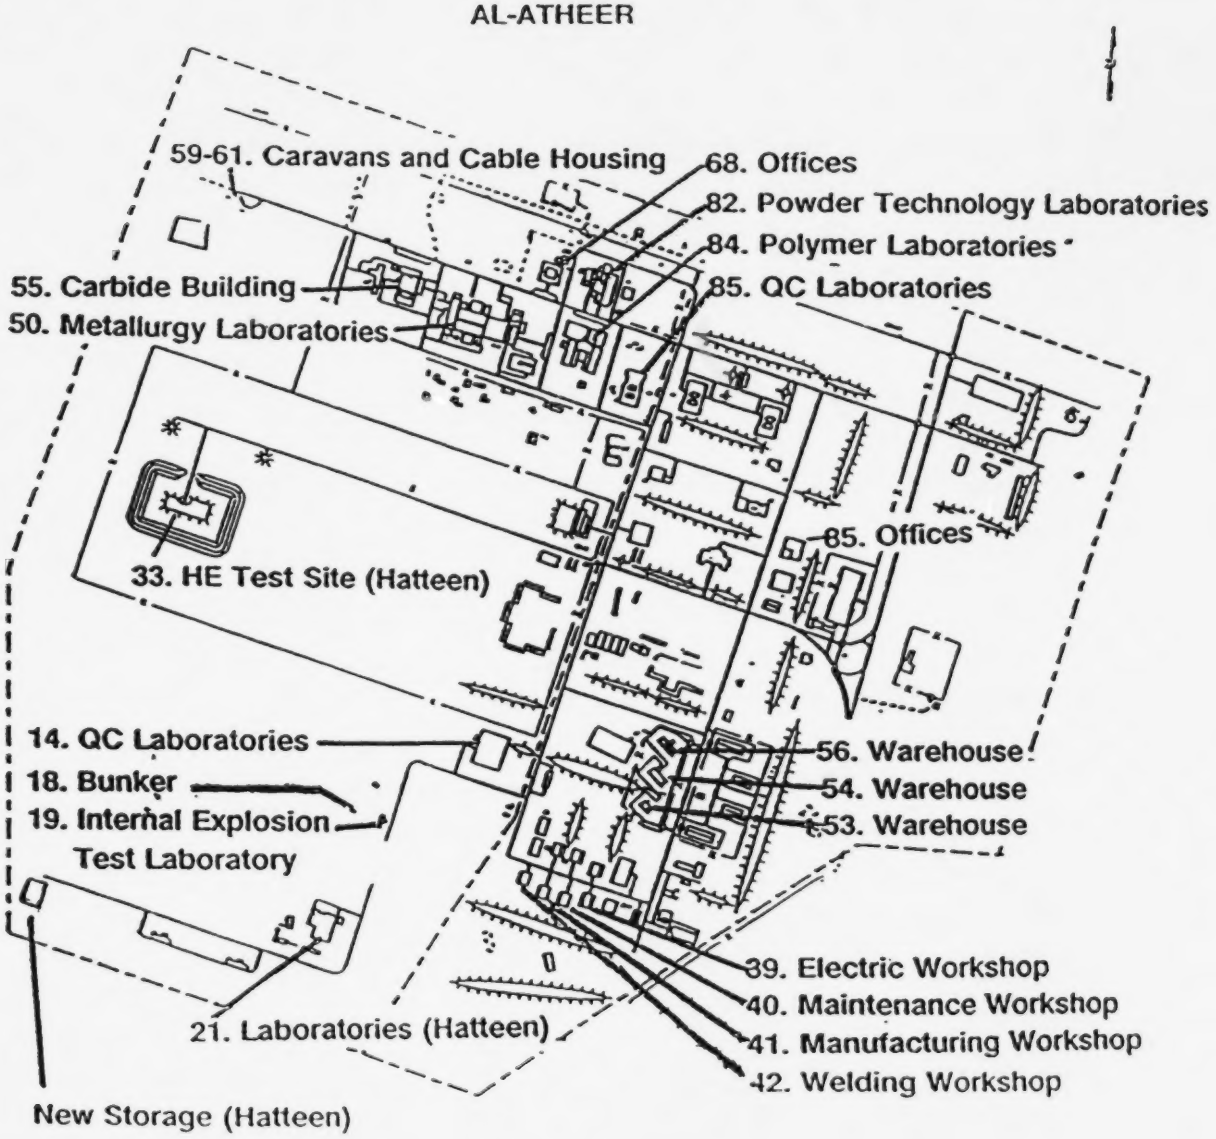
Figure 1

1. Building 33 - The high explosives test bunker was destroyed by filling it with concrete and scrap metal. The protective berm has been removed.

2. Building 18 - Explosion chamber destroyed with cutting torch.

3. Building 19 - Control building destroyed by explosives.

4. Building 21 - Physics building destroyed by explosives. Cell foundation destroyed with cutting torch.

5. Building 50 - Casting building destroyed by explosives.

6. Building 55 - Carbide building destroyed by explosives.

7. Building 82 - Powder building destroyed by explosives.

8. Building 84 - Polymer building destroyed by explosives.

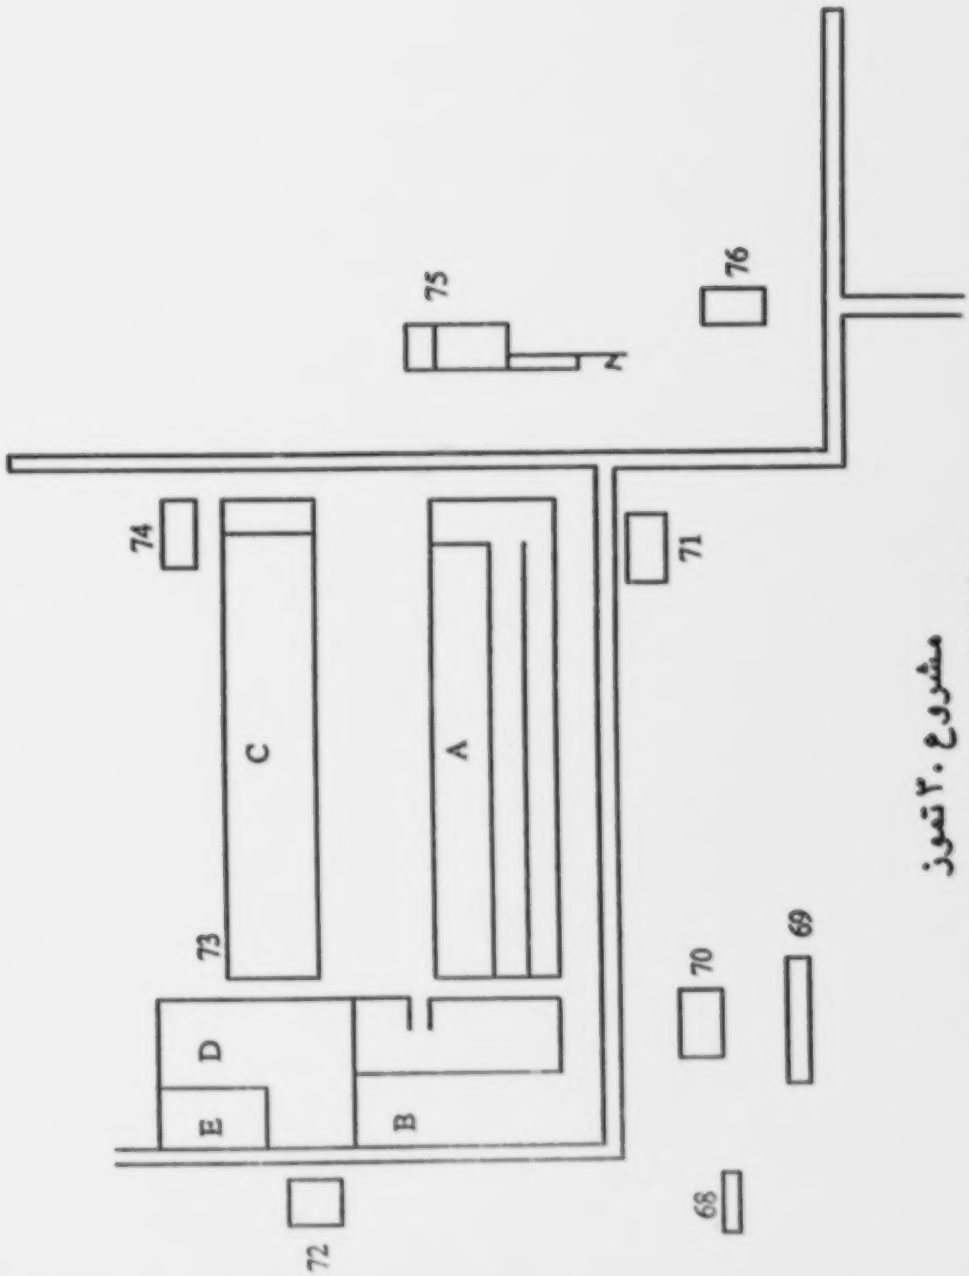
Figure 4

During the twelfth inspection mission, the Iraqi side explained that "Building 73" referred to a complex of buildings (see Figure 4). Of this complex, Buildings

73A and 73B were under safeguards. In addition, the Iraqi side declared that the activities involving the unsafeguarded material had taken place in Building 73C except for the production of 18.9 kilograms of natural uranium as five fuel elements, of 26 kilograms of natural uranium as pellets and of 14 kilograms of natural uranium as 46 fresh fuel pins; these had been produced in Building 73A using UO_2 from Al Jesira. The production of the five fuel elements, their irradiation in the IRT 5000 reactor and the reprocessing of three of them had been previously declared and the corresponding non-compliance with the safeguards agreement between Iraq and the IAEA communicated to the IAEA Board of Governors. Figure 5 includes the processes declared as having taken place in Building 73C. Building 73C had been declared in the past as containing only utilities and a mechanical workshop (including the electron beam welder).

Layout of the Building 73 complex presented by the Iraqi authorities
